OCSD-A / AeroCube-7A Status Update

Microsatellite Systems Dept.
April 20, 2016

OCSD-A Software Update Anomaly Overview

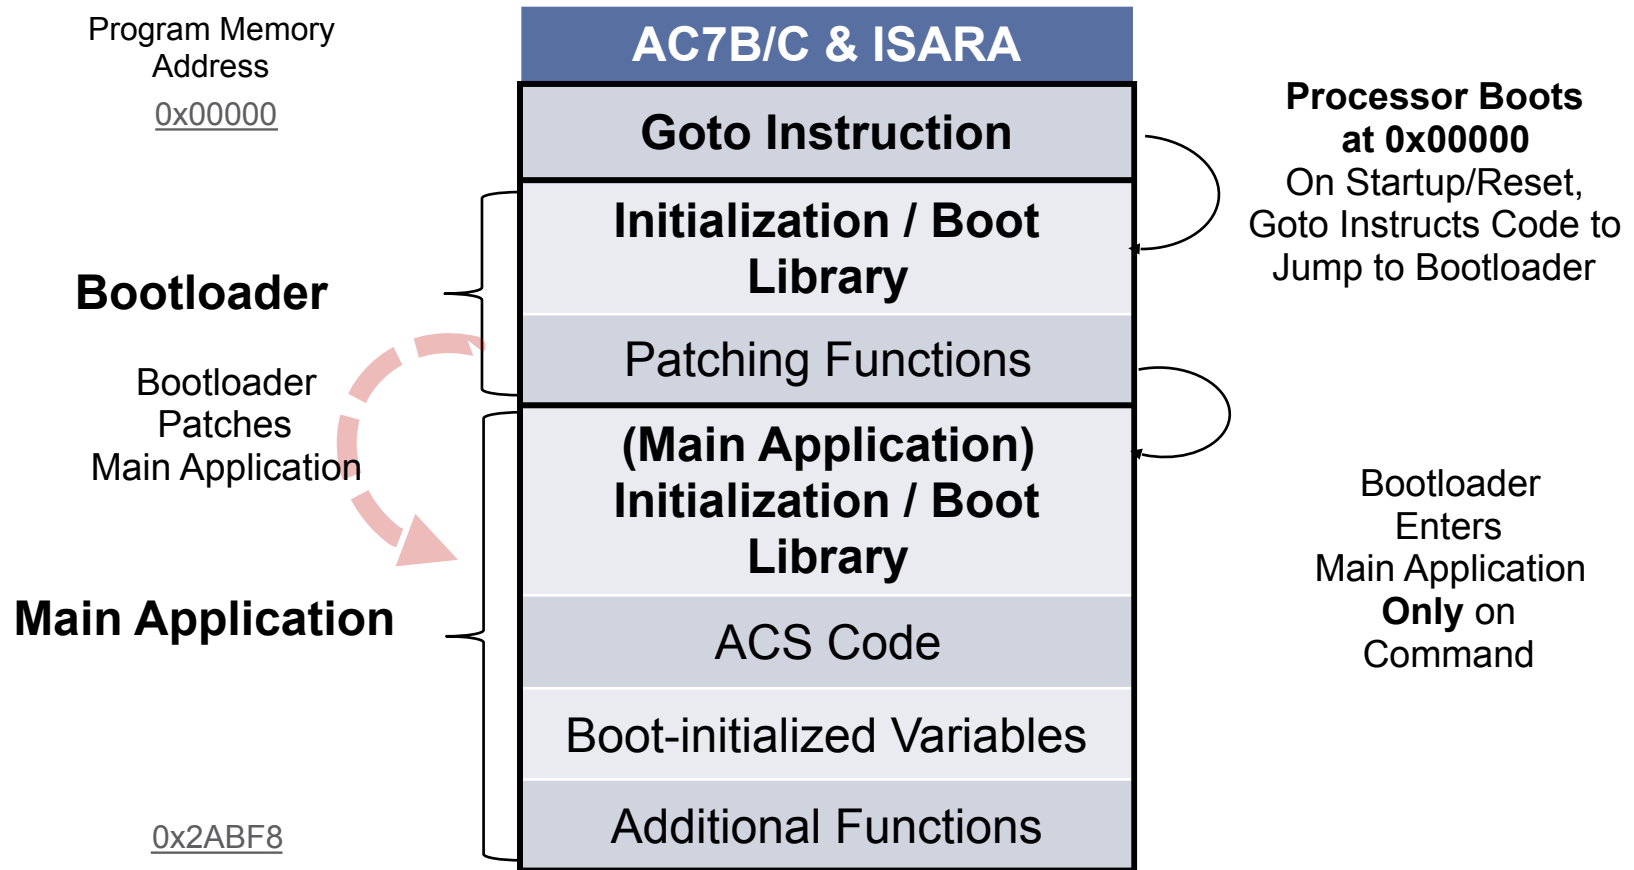
Bootloader Application

- > *If Main Application Fails, Bootloader can still patch/update the application*
- > *Currently on 8-bit Sensor, Propulsion and Reaction Wheel PICs*

Separate Patch Functions from Main Application

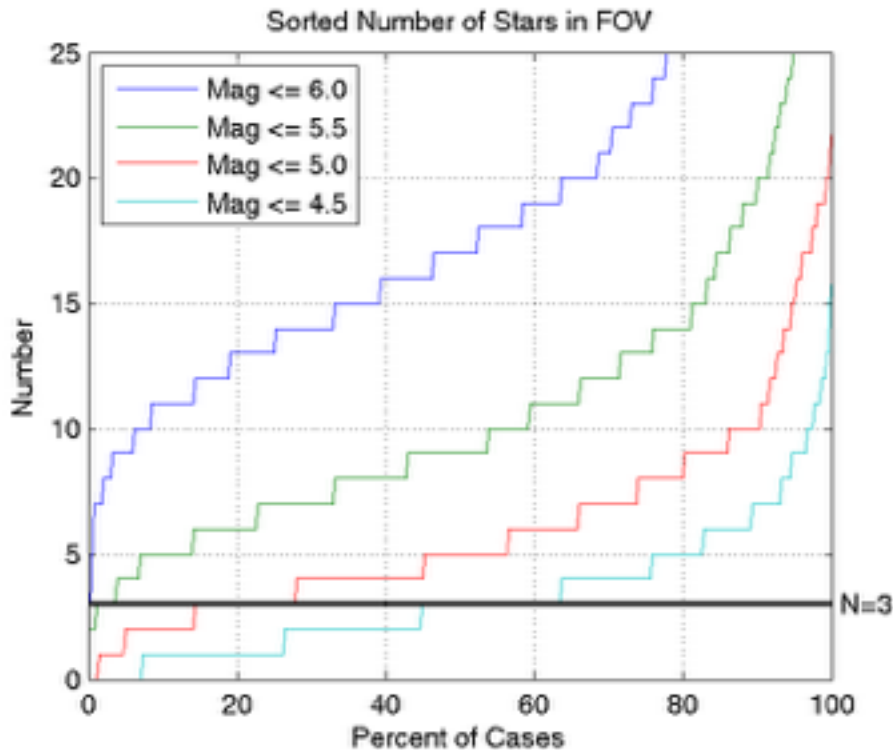
Star Tracker Solution Probability

- On-orbit sensitivity data supports analytical studies to determine the probability of obtaining a valid solution at maximum mission slew rates
