MarCO MiPS

Going Where no CubeSat Propulsion System Has Gone Before

Chris Day
April 24st, 2019

JPL Mars Cube One (MarCO) Mission

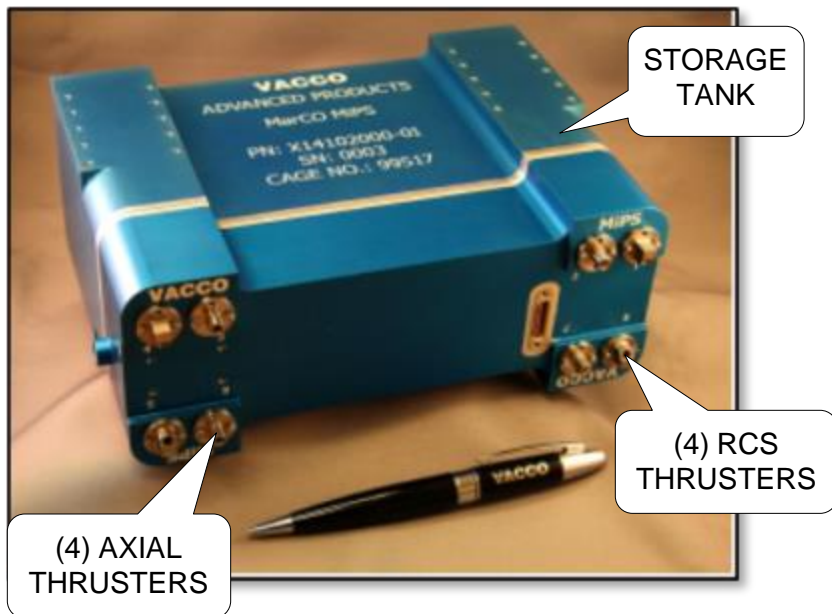
JPL MarCO Micro Propulsion System

Smart, Self-Contained Propulsion System:

- ⊕ Contract for (2) Flight Systems
- ⊕ **755 N-Sec Total Impulse**
- ⊕ 3490 gram Wet Mass

System-in-a-Tank Design Including:

- ⊕ Propellant Storage & Feed System
- ⊕ (4) Axial & (4) RCS 25mN Thrusters
- ⊕ Controller & Sensor Suite

Two Interrupts Against Leakage

All-Welded Aluminum Alloy Construction

Microcontroller Driven:

- ⊕ RS422 Digital Interface
- ⊕ Controls Burn Type & Duration
- ⊕ Closed-Loop, Variable Thrust Control
- ⊕ (3) Settable Thermal Control Zones
- ⊕ (3) Power Supplies, (9) Valve Drivers

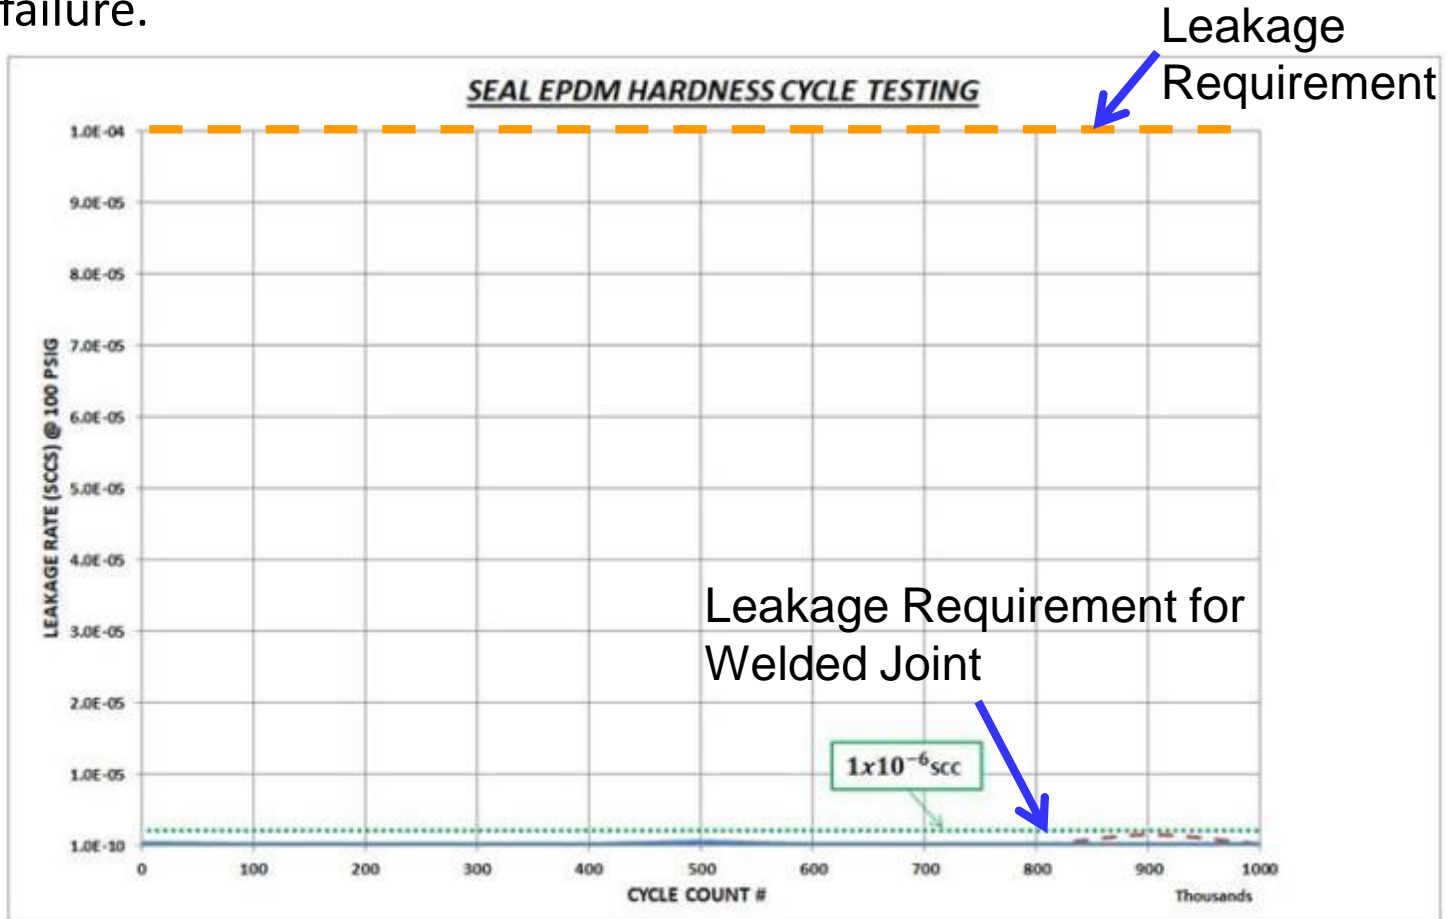
Micro Valve Design Verified to 1 Million Cycles Without Leakage

Verify Cycle Life of Micro Valve with EPDM seal:

Concern: Is PCV cycle life adequate?

Solution: VACCO performed a PCV cycle life test that verified one million cycles without failure.
